CRREL REPORT

Design and Evaluation of a Towed Snowplow for the Small Unit Support Vehicle (SUSV) Full-Scale Prototype Development and 1992 Field Tests

Paul W. Richmond and Michael R. Walsh

October 1994

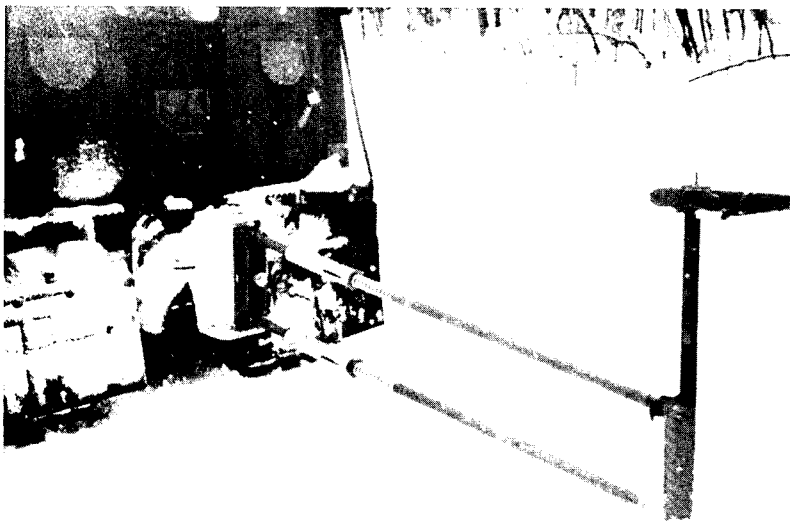
Figure 1. Four-bar towing linkage.

The full-scale plow shares many features with the half-width model. Primary among these is the four-bar linkage towing mechanism (Fig. 1). This mechanism attaches to the SUSV pintle mount through an adapter (Fig. 2). The four-bar linkage consists of a tractor link, two towing links and a plow link.

The tractor link attaches to the pintle mount adapter through a central pivot stub axle, which

allows the plow to roll in the axis of the SUSV. In addition, the adapter pivots in the vertical axis (yaw), which allows the plow to follow directly behind the SUSV in both the towing and plowing configurations. Attachment of the tractor link to the adapter is through a shear pin, designed to fail at 41 kN, safely below the maximum drawbar capacity of the SUSV (49 kN). The tractor link has two clevises located 30.5 cm apart for attachment of the upper and lower towing links.

The plow link is an adjustable block attached to the plow. Like the tractor link, it has two clevises mounted 30.5 cm apart to accept the towing links. The plow link is vertically adjustable in 15.25-cm increments to adapt the towing mechanism to varying snow conditions. The total adjustment range is 45.75 cm. The pivoting plow link rod, to which the plow link is mounted, is attached rigidly to the front plow skid. The plow link pivots in bearings mounted at both ends of the rod. This feature, along with the parallel rotating axis on the tractor link, allows the plow to track directly behind the SUSV. For road transport (discussed later in this report), the plow link is locked to eliminate rotation. The plow and tractor links are parallel when the equipment is on a flat surface.

The final two components of the towing mechanism are the towing links, which attach to the plow and tractor links. The towing links are 1.75 m in length, which allows sufficient vertical travel between the rear of the SUSV and the plow for operations in deep snow. These links are longer than the ones used on the half-width model and solved some of the vertical control problems attributed to the 1.25-m links on the half-width model. The plow links have a spring-loaded section that allows the plow to ride over a 16-cm obstacle without overstressing the mechanism. Their lengths can be adjusted to control pitch and to facilitate mounting and attachment of the four-bar towing mechanism to the SUSV.

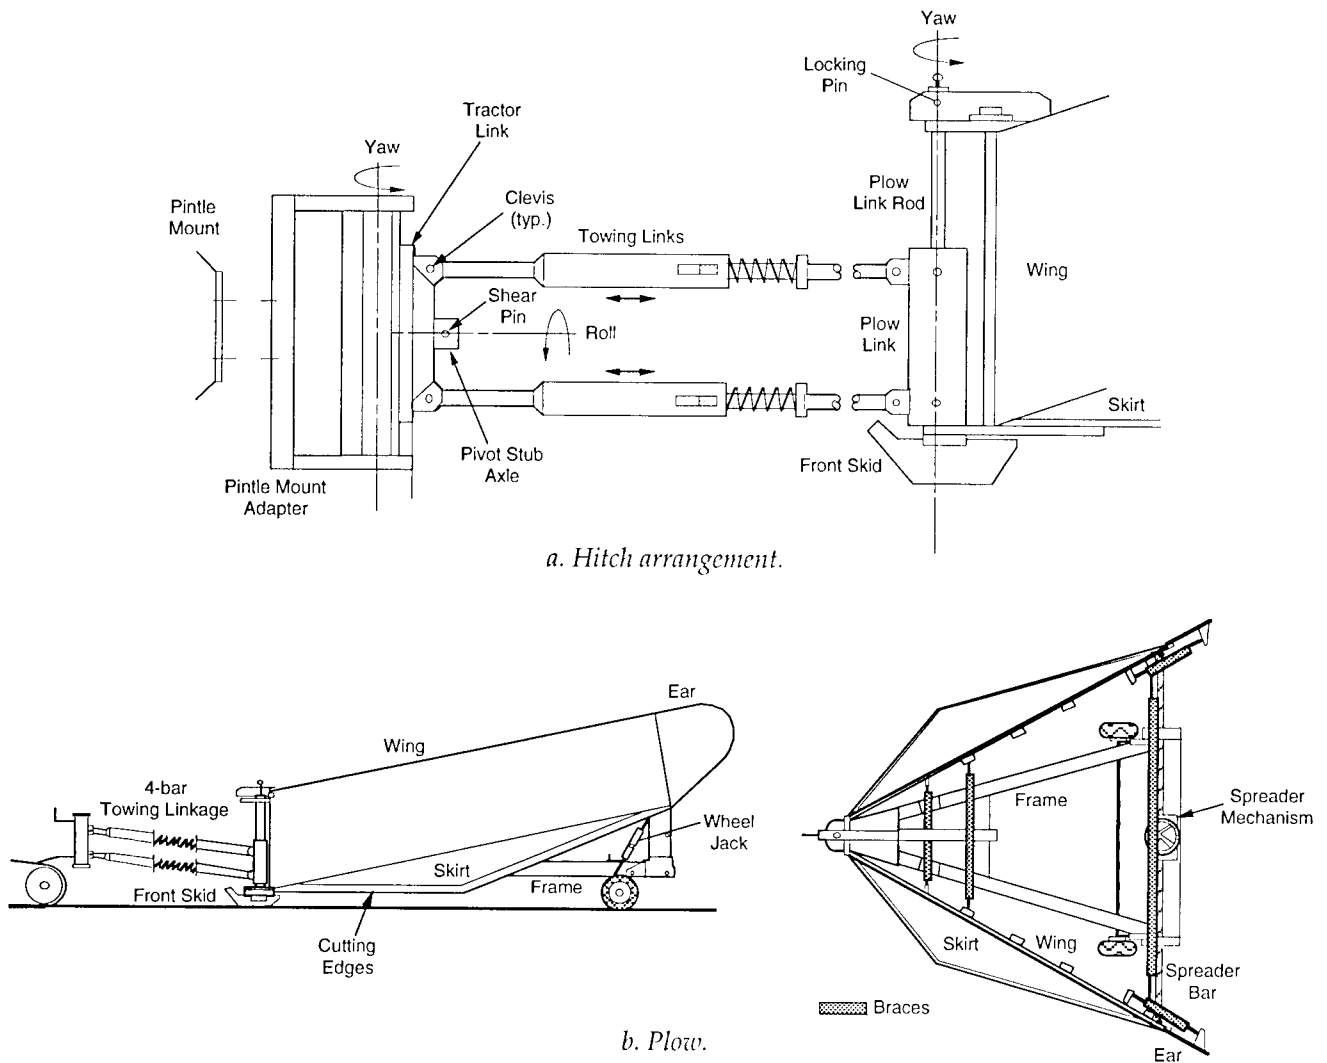
Figure 2. Schematic of plow and hitch.

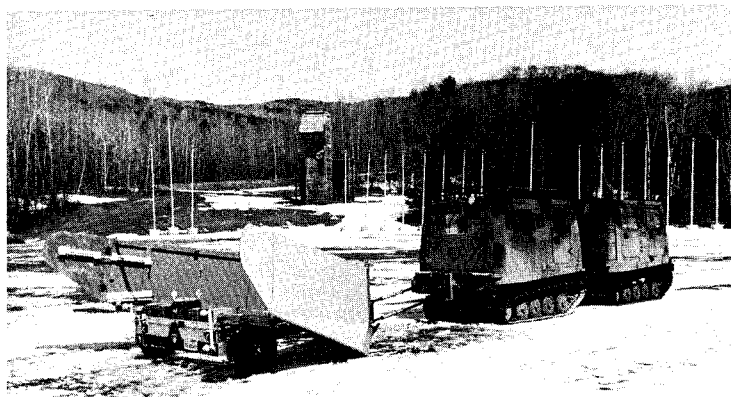
Figure 3. Full-scale prototype plow mounted to the SUSV.

The V-plow is constructed primarily of welded aluminum with steel cutting edges and with a

covering of ultra-high-molecular-weight polyethylene (UHMW PE) on the plowing surfaces (Fig. 3). Borland (in prep.) investigated possible plow coatings and found UHMW PE to be the best coating tested for this application. The plow is designed to ride on three points: a front skid and the two rear wheels. Three plowing widths are available (measured at the wing ends): 2.1 m (fully closed), 3.1 m (half opened) and 4.1 m (fully opened), corresponding to angles of 30°, 45° and 60°. The wings are hinged at the plow nose, and a manually operated rack-and-pinion spreader mechanism (Fig. 4) is used for adjustment. The maximum plowed path width in 1 m of snow is 2.4 m. Bracing in several locations is used to keep the plow blade stable during transport and use. Wing extensions (ears) fold in to facilitate shipping.

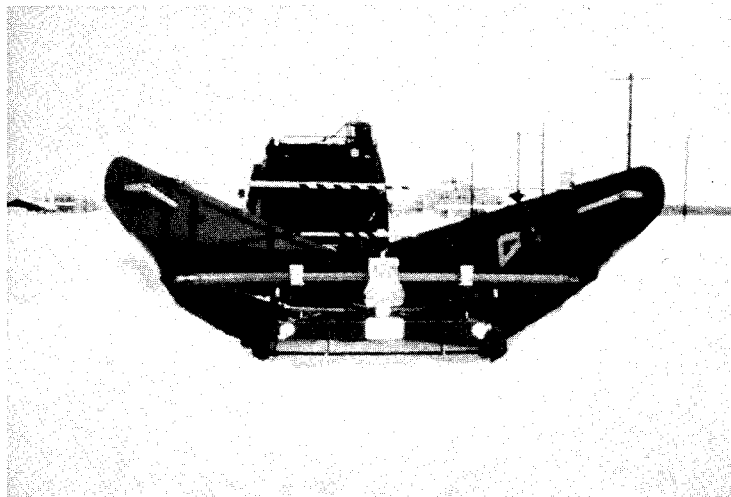
Figure 4. Rack-and-pinion spreader mechanism.

To open the plow to the half-open position, the upper central cross brace is removed and the rear of the plow spread using the rack-and-pinion mechanism (Fig. 4). With one end of the long brace attached to an upper rear clevis, the plow width is adjusted until the other end is in position and locked to the opposite clevis. The central cross brace is then installed into the center set of clevises (in the middle of the plow), and the spreader arms are locked in place. The ears should be deployed when plowing in half-open or fully open conditions. The exception to this rule would be in locations of shallow snow or confined areas.

The spreader mechanism as designed was not robust enough for this application. Although it performed adequately, a number of persistent problems exist. The major problem was inadequate stiffness. At the fully open position, the ends of the spreader bars sagged at least 4 cm. Lack of stiffness in the plow axis was a problem during opening and closing of the plow, as the bearing points at the end of the bars would stick on the end slides and bind. This was partially the fault of the end slides, which also need to be redesigned. Binding due to alignment problems within the spreader mechanism was also a problem that will need to be addressed in future designs. Finally, a better position-locking design is needed.

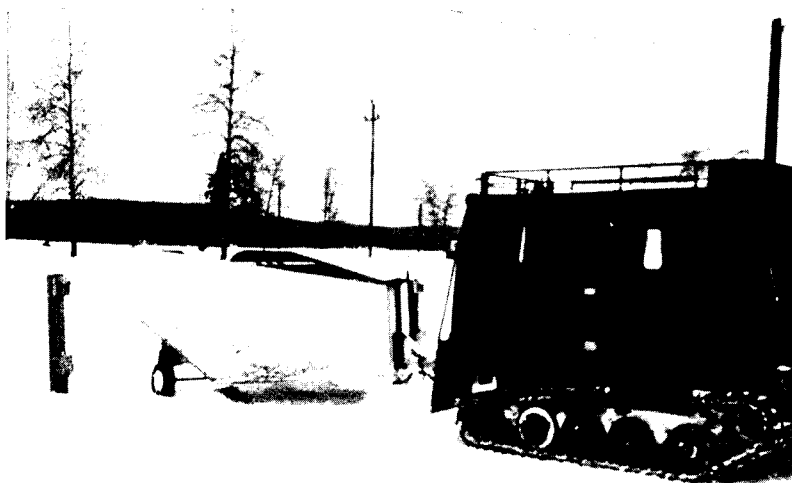
Figure 5. Road transport configuration.

Transporting the plow to the point of deployment is an important aspect of the plow operation. The plow can be transported with any vehicle equipped with a pintle hook and trailer light receptacle. During transport on the road, the wings are fully closed, and the ears are folded and locked in the transport position (Fig. 5). The long cross brace is stored in its retracted length on the inside of the left wing of the plow. The upper central cross brace (Fig. 2) is attached to the rearmost of the three clevises for this brace. To prepare the plow for transport, both rear wheels are chocked, and the upper and lower towing links are removed and stored at the rear of the plow. The towing adapter, stored on the right rear wing, is attached to the plow link, using the two clevises. This link must be at the lowest adjustment point for jacking and towing. Also, the plow link rod must be locked with the $\frac{3}{8}$ -in. pin provided.

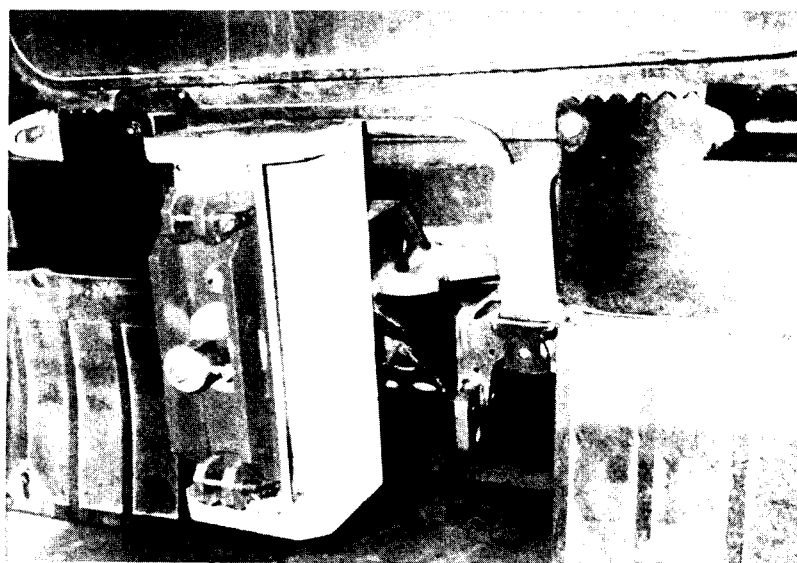
a. Pintle hook adapter.

b. Pintle mount adapter.

Figure 6. Pintle adapter.

The pintle hook adapter is then attached to the pintle mount adapter on the back of the SUSV (Fig. 6). The pintle eye is raised to the level of the pintle hook using the integral jack on the towing arm. The SUSV is then backed up to the pintle eye on the towing arm, and the connection is made. The pintle hook is closed and locked, the jack lowered, and the weight of the front of the plow is taken by the pintle. The rear wheels are lowered to increase ground clearance. The towing safety chains are attached, the rear lights connected, the chocks removed and stored, and the plow is ready for transport. The plow has been towed at speeds in excess of 95 kph over well-maintained roads. High speeds on rough roads are not advisable, as the plow does not have an adequate suspension system to handle the impact forces and displacements encountered under these conditions.

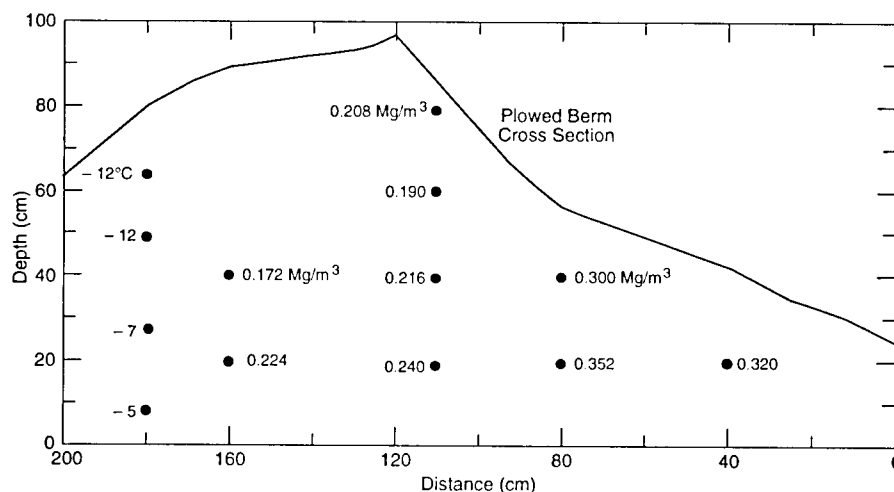
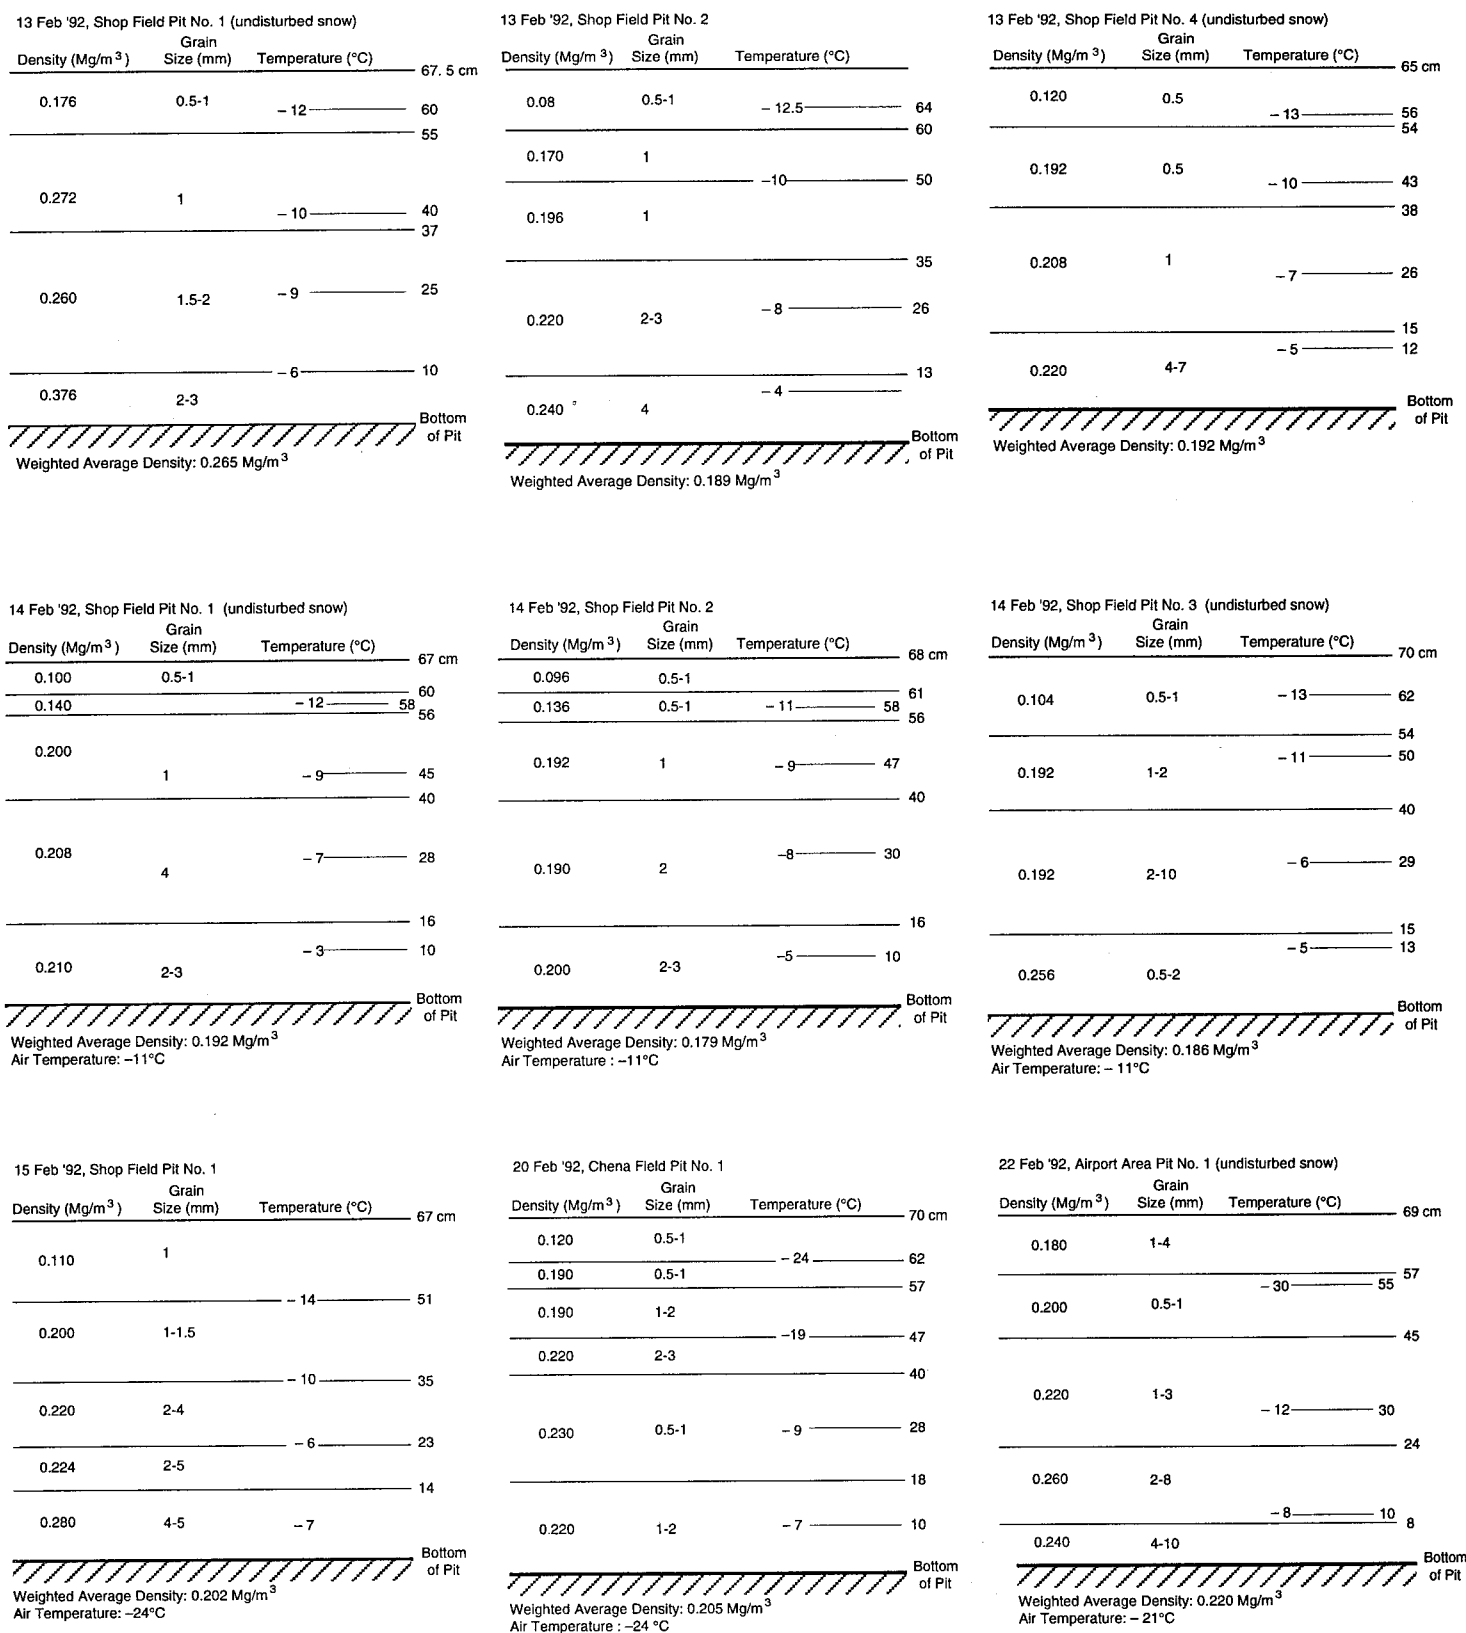
Figure 7. Snow characteristics at Ft. Wainwright.

Figure 7 (cont'd).

Four test areas were used at Fort Wainwright. Three of the areas were flat and generally covered with undisturbed snow. These are identified as the shop field, the airport field and the Tanana River firing range. A ridge of blown snow was encountered at the airport field, and multiple plowed access roads were crossed at the firing range. The fourth area, Chena field, contained a depression with a 20% slope, and the area had been subjected to extensive snowmobile traffic. In general, the snow was 60–90 cm deep and was not well bonded. Snow pit data from the Fort Wainwright test areas are given in Figure 7. Table 1 contains a summary of all the snow data obtained during tests.

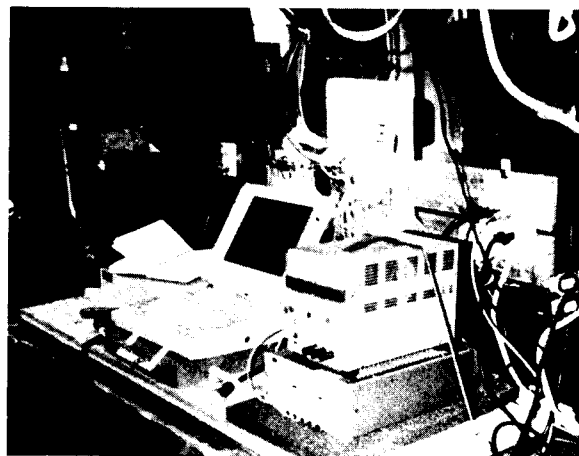
Figure 9. Test instrumentation and data acquisition system.

A set of measuring and recording instruments were installed in the rear unit of the SUSV used at Ft. Wainwright so that various vehicle and plowing variables could be recorded (Fig. 9). A detailed description of the instrumentation is reported in Walsh and Richmond (1992) and Osborne (1991). Table 3 presents a list of the variables measured

and the measuring devices used in these tests. The analog data were multiplexed and digitized using an Elexor PL-1000 data acquisition system controlled by a laptop computer. Data were stored on the laptop's internal hard drive for later analysis. Electrical power was supplied by a 2.2-kW generator strapped to the roof of the SUSV rear unit. The only significant change from the instrumentation package described by Walsh and Richmond (1992) was the replacement of the tilt sensors.

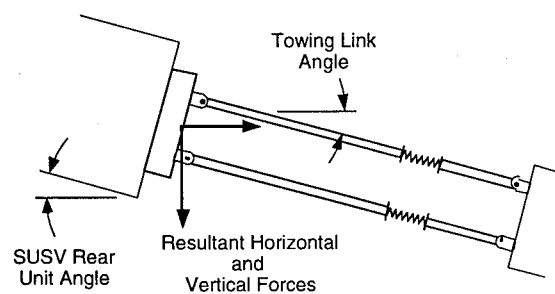
Figure 10. Relationship of reported force components.

Towing forces were analyzed by determining the horizontal and vertical components of force in each of the towing links and summing the component values for both links. The angle measured by the tilt sensor on the top link was used to determine the components. Figure 10 shows that the values reported are always in reference to true vertical and horizontal regardless of the SUSV attitude. For comparison be-

tween tests, this simplification affects only those tests on significant slopes. Almost all the tests were conducted on level terrain, and for these tests the horizontal and vertical component values represent the towing resistance and

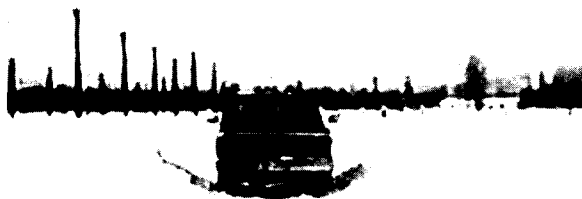
Figure 11. Pickup truck driving in a plowed path.

At this point the plow was opened to full width, and tests were done without difficulty. A commercial four-wheel-drive pickup truck was driven around this full-width path without difficulty (Fig. 11). Cross sections of the full-width plowed area are given in Figure 12 and are probably representative of these test conditions only, as many factors will influence these dimensions.

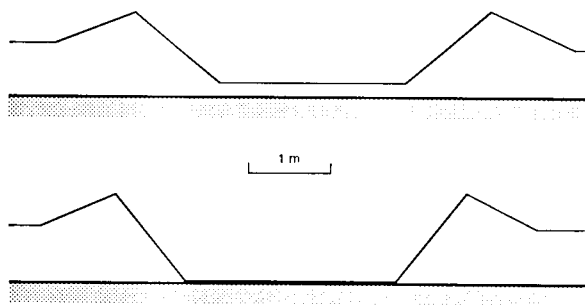
Figure 12. Cross sections of plowed paths.

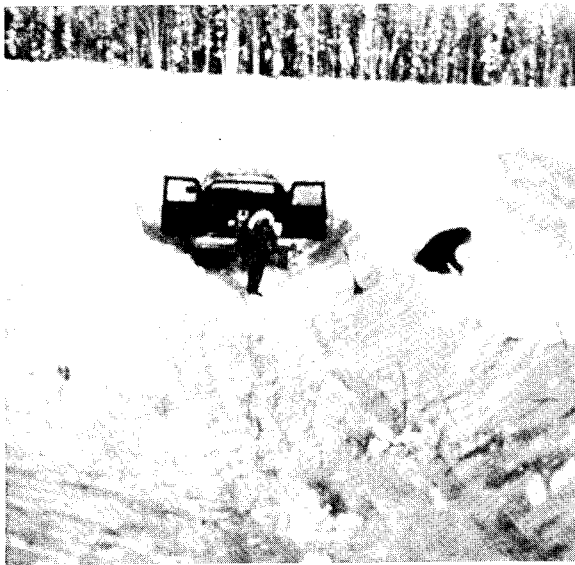
Figure 13. Vehicle parked at the base of a plowed slope.

hill with the plow fully open. The SUSV again became stuck, and the data indicate that the slope was about 12° (20%) when the SUSV stopped. The snow depth was about 76 cm. It should be noted that in deep, dry, loose snow, as we encountered here, the maximum gradeability for the SUSV alone is 30%. The plow was closed to the half-open position, and the SUSV was able to continue up the hill (test 0220A02). Test 0220A03 was a replot of this lane with the plow fully open. Figure 13 shows a four-wheel-drive vehicle parked at the base of the slope. The tilt sensor data for the rear SUSV unit (Fig. 14) indirectly indicates the slope angles encountered during these tests.

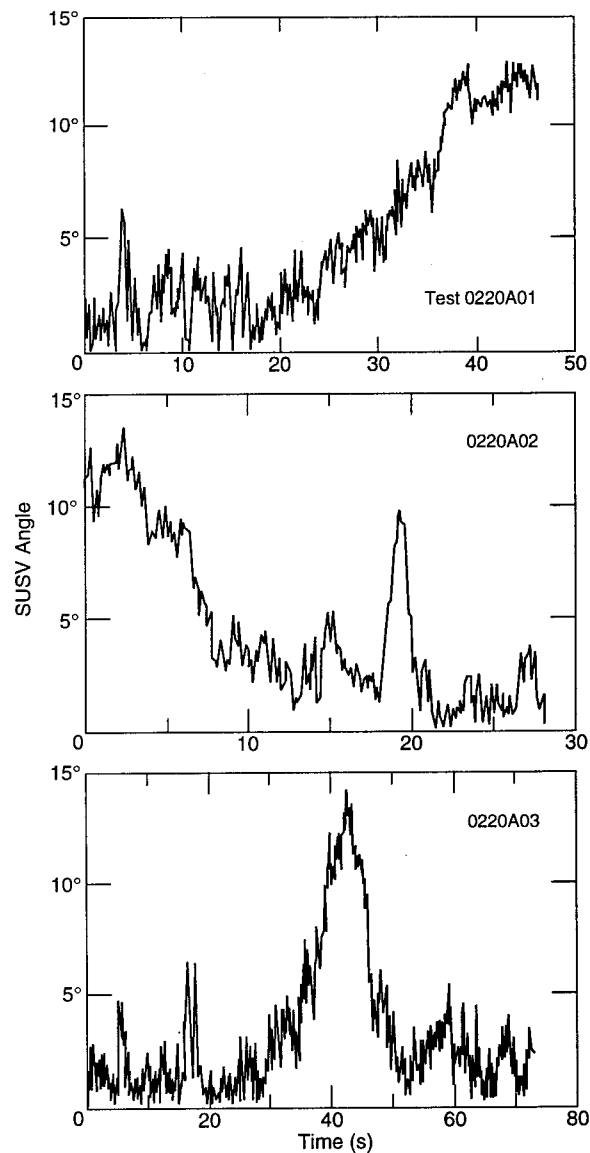
Figure 14. SUSV angle on a slope.

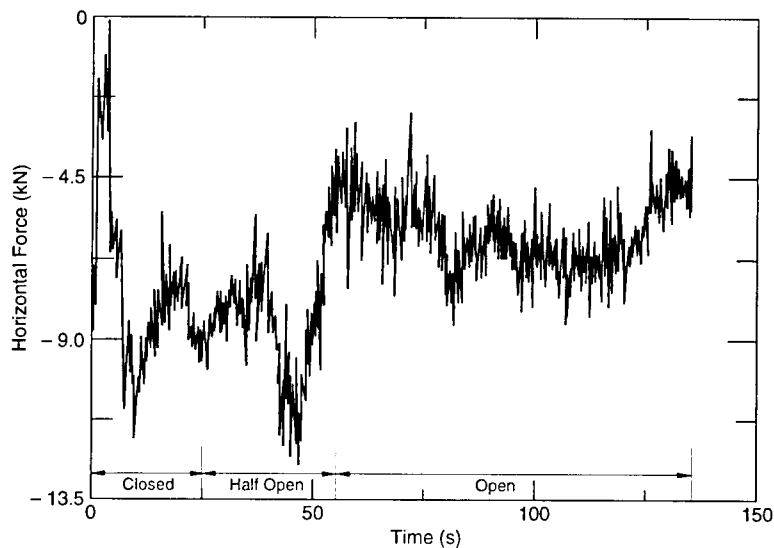
Figure 15. Horizontal forces during plowing of a previously plowed path at three widths.

hour. While this area was hardening, a series of tests (0222A01–0222A03) were conducted with the plow fully open, half open and closed. Data were recorded after the SUSV reached a speed of about 4.8 kph (3 mph) and was in a previously undisturbed area. These tests indicate that, as expected, towing resistance decreases as the plow is closed. Closing the plow from fully open to half open reduced the resistance by about 1.69 kN (380 lb), or about 27%. Fully closing the plow further reduced the resistance by 0.29 kN (65 lb), or about 6%. The reduction in resistance of only 0.29 kN (65 lb) between the half-open and closed positions seems low compared to the reduction between the fully open and half-open positions. The frontal widths or forward projections of the plow in the three positions are 4.1, 3.1 and 2.1 m for the fully open, half-open and closed positions, respectively (wings only). Included plow angles for the three positions are 60°, 45° and 30°, respectively, for the wings. The only apparent cause for the small reduction in force between the half-open and closed plow drawbar forces is the influence of the plow skirt. When the plow is fully opened, the ratio of skirt width to wing width is 0.73. For half-open and closed positions, the ratios are 0.84 and 1.01. While the wings tend to displace the snow laterally from the towing axis, the skirts lift and laterally displace the snow, a process that requires more force. As the skirts become the more dominant factor in snow displacement, the reduction in force due to closing the plow may become less. There were no other similar tests that could be compared to these to verify this pattern.

Plowing a previously tracked and hardened SUSV path indicated an increase of drawbar force of about 40% over plowing an untracked area. A significant decrease in drawbar pull, over 25%, was found between plowing at full width versus half width. Closing the plow further to the fully closed position decreased the total force less than 10%. The hill-climbing capacity of the system is limited by the gradeability of the SUSV. On the 20% slope the available drawbar force was 10.2 kN, about 40% of the value obtained for level terrain. This is better than the estimated decrease due to grade, about 69%. One possible solution to climbing grades would be to prepack the path with a SUSV without a plow and then attempt to plow a full-width path.

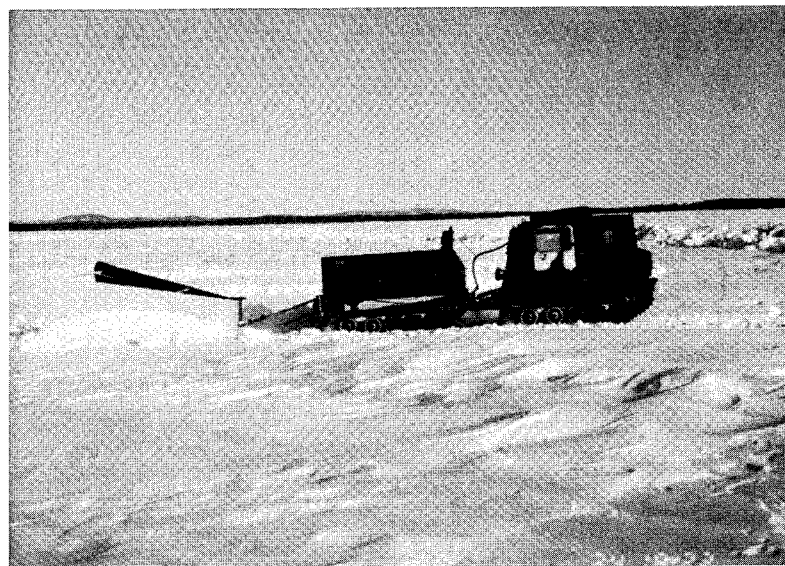
Figure 16. Plow attached to a cargo version of the SUSV, Ft. Greely.

During this period the plow was towed 175 km from Ft. Wainwright to Ft. Greely to test the plow in significantly different snow conditions. At Ft. Greely the plow was attached to a Cargo-version SUSV (Fig. 16). This SUSV had a six-cylinder engine as opposed to the SUSV used at Ft. Wainwright, which had a five-cylinder engine. It is not believed that these differences greatly affected performance. An additional difference was the height of the adapter hitch above the ground: on the Ft. Wainwright SUSV the adapter was mounted 59 cm above the ground so that the rear door of the SUSV could be

opened; at Ft. Greely the adapter was mounted 78 cm above the ground. This changed the angle of the towing assembly by 6.4° and the drawbar efficiency from 99% to 97%. No plowing resistance measurements were made, as the instrumentation was not brought to Ft. Greely because of time constraints. All transport of the plow at Ft. Greely was done with the SUSV.

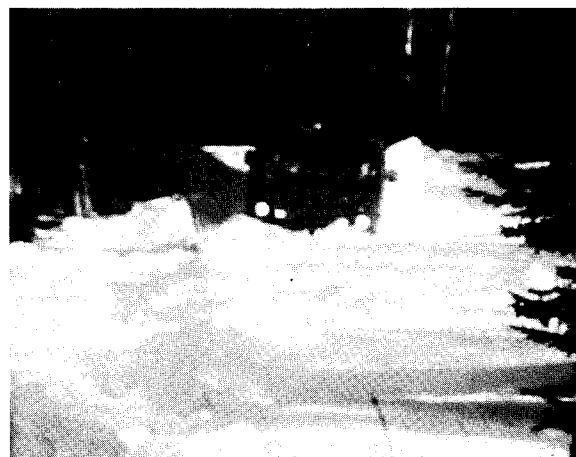
Figure 17. Terrain at the Bolio Lake test site.

The second area in which plowing was done was on a trail in a forested area (near Bolio Lake). Here the snow had not been compacted as much by wind, although snow characteristics were very similar to those at the other two sites (Fig. 17). Open areas had as little as 20 cm of snow, whereas in protected areas, snow drifts were as deep as en-

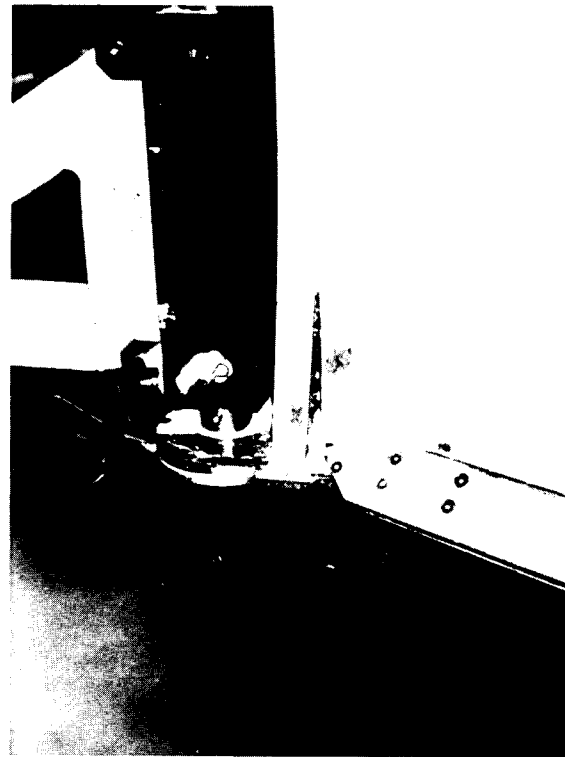
Figure 18. Broken welds on the plow structure.

second gear at a speed of about 9 kph. Plowing was done with the plow fully open, and some damage to the plow occurred. The damage consisted of a broken weld where the left wing is attached to the pivot for opening and closing the plow.

A number of welds cracked during testing, but again, none halted testing. The most significant

failure was along the left wing pivot bar, where about half the weld was cracked and the base of the wing pulled away about 3 cm (Fig. 18). This was repaired at the motor pool at Ft. Wainwright after completion of that day's testing. Damage was also sustained to the cutting edges at that time. Soil and wood jammed between the cutters and the skirt, forcing the blade out about 1 cm between anchoring screws. Excess debris was removed and testing continued. Another weld failed on one of the supporting outriggers for the rack and pinion. This also did not affect testing and was repaired later in that day after testing.

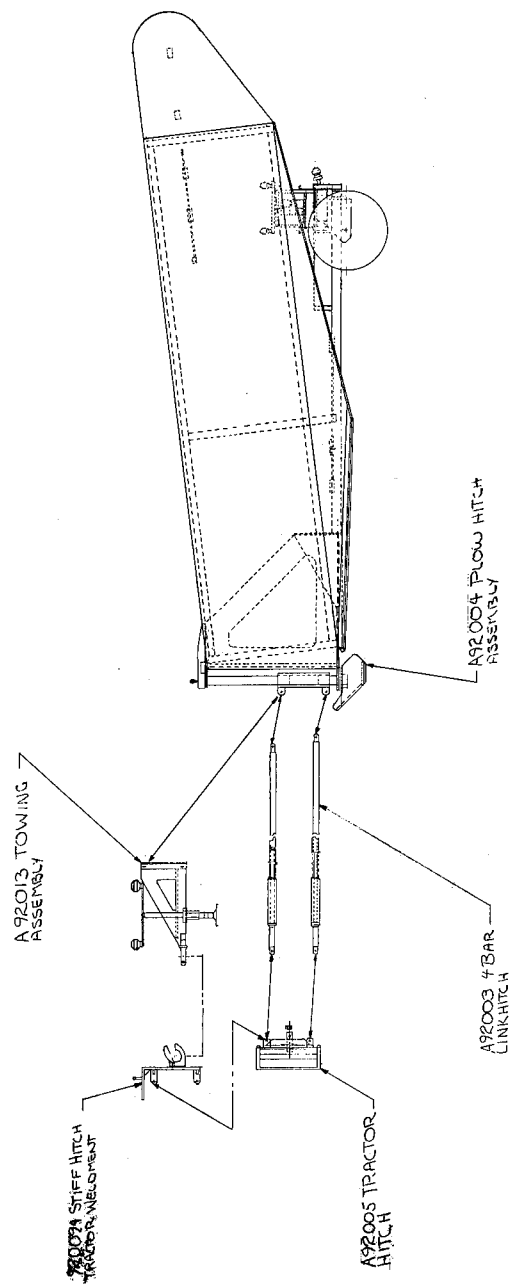
The first two pages contain overall illustrations of the major assemblies of the plow, the four-bar link towing mechanism and the plow. Subsequent drawings are of subassemblies of these major assemblies.
